Center Harbor Energy Committee *DRAFT* Summary of Highway Garage Visit on 26 September 2016.

Center Harbor Energy Committee Highway Garage Visit – September 26, 2016

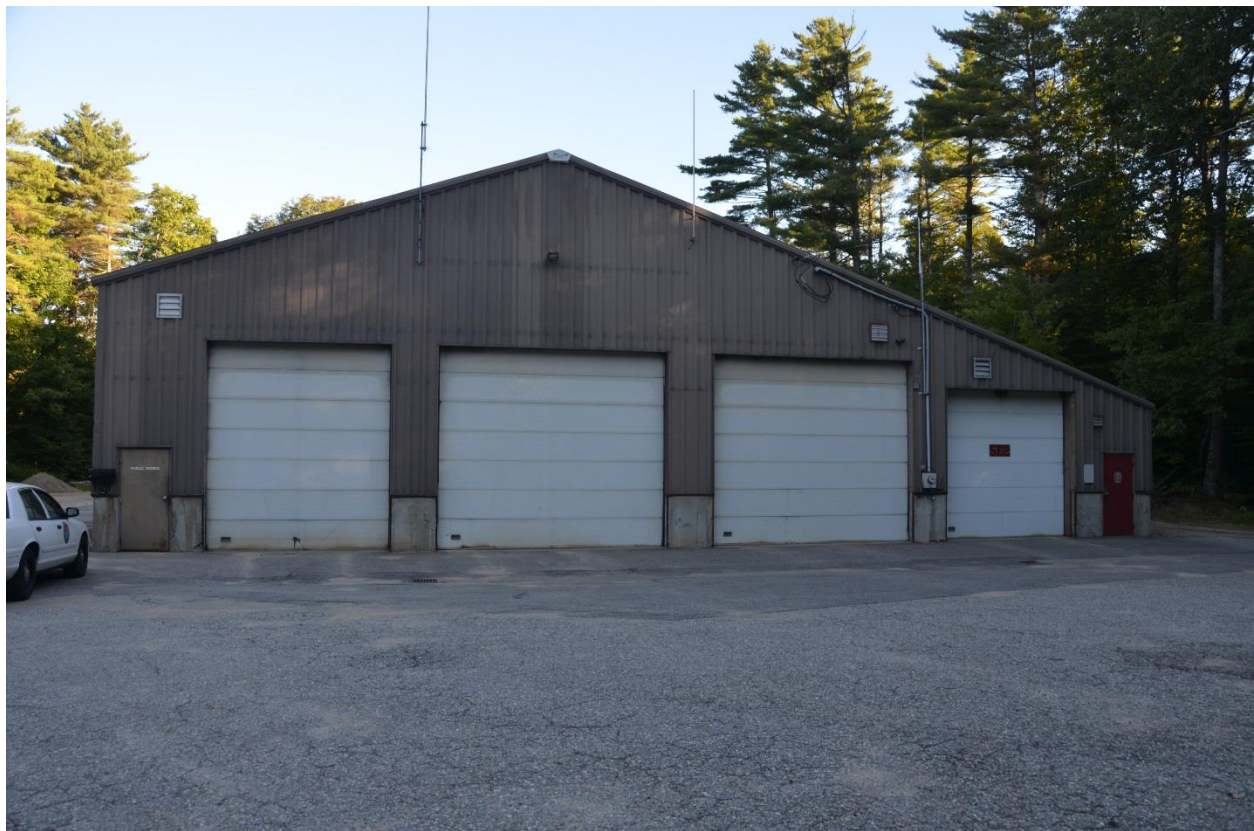
Above – Front of building with 3 main bays for highway garage and firetruck bay at right end.

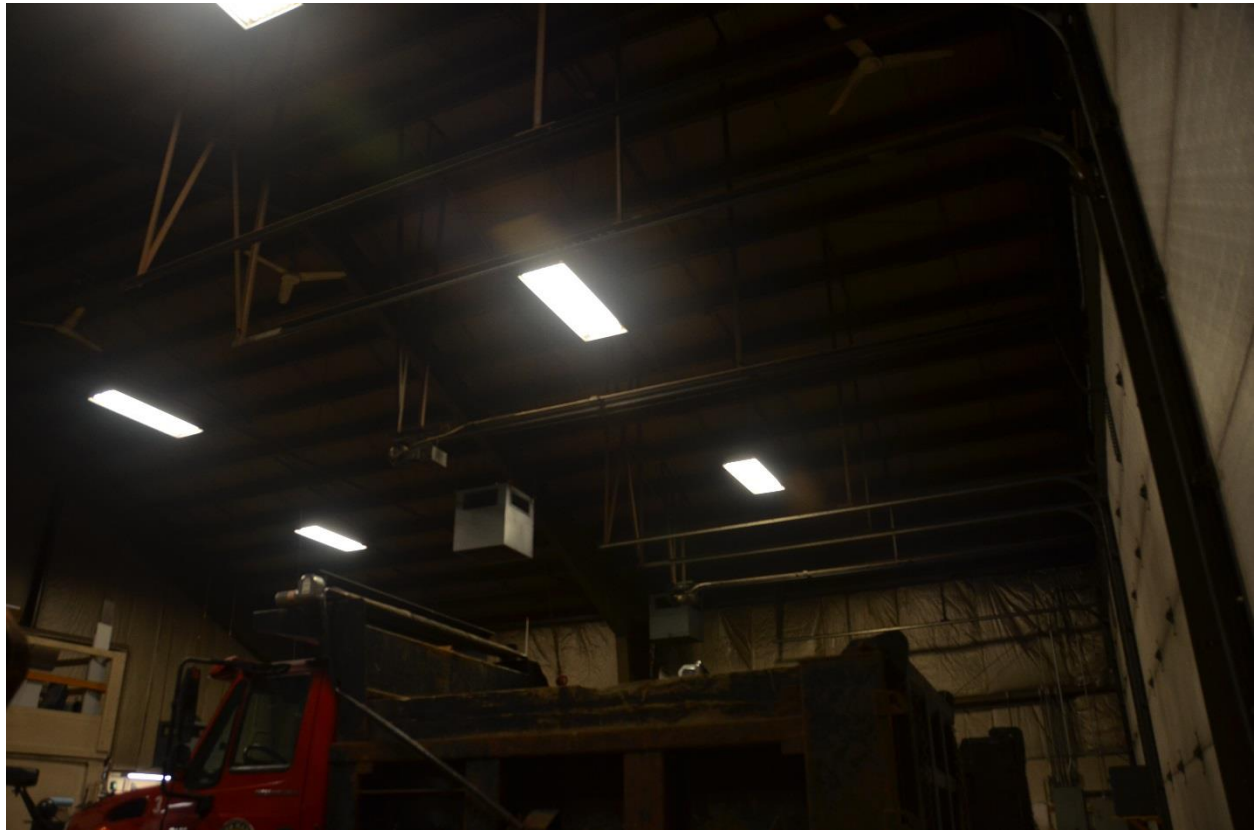
12. These diesel fume scrubbers and the garage door tracks are below the main ceiling. A false ceiling just above these might be an option.
13. While the more energy efficient lighting improved conditions, it is still not as well illuminated as they would like. Improving the amount of lighting needs to be investigated.

Above: Door tracks, diesel scrubbers, and lights in heated section.

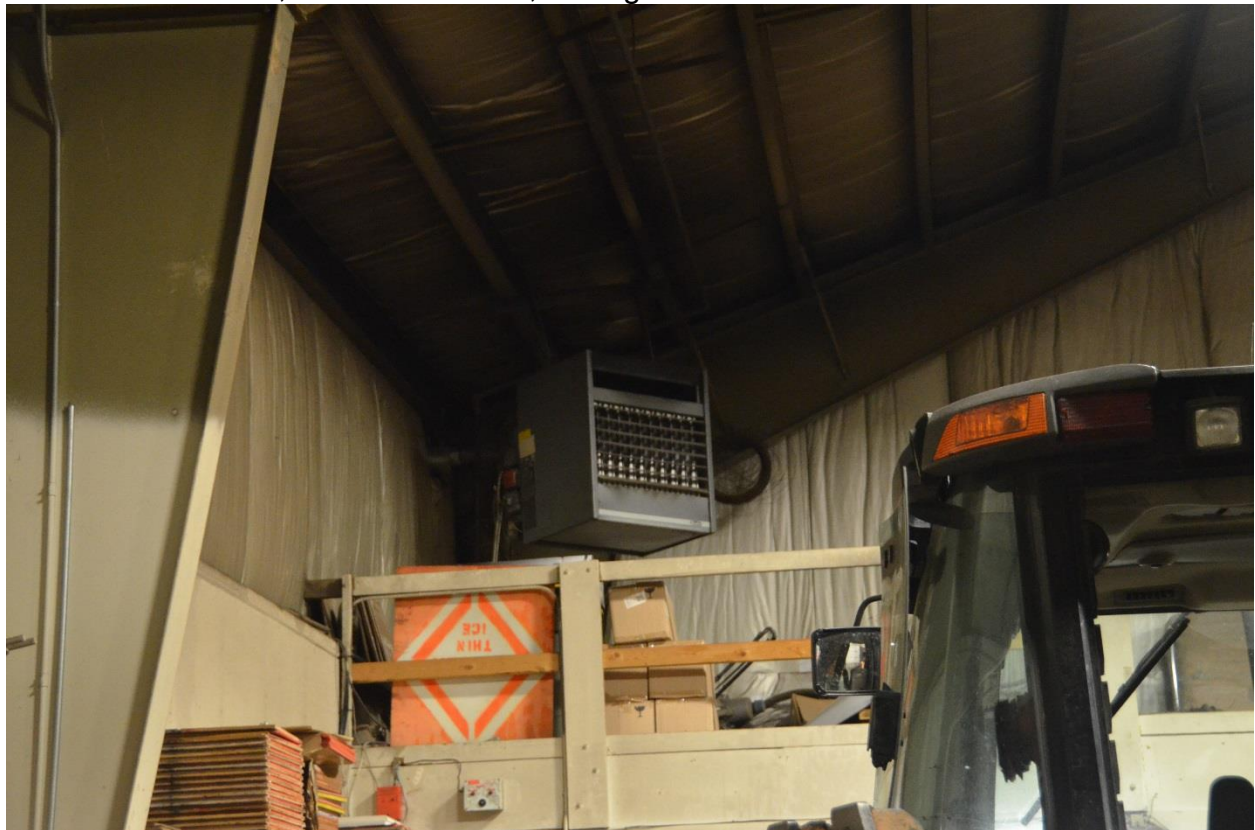
Above: Heater in corner.

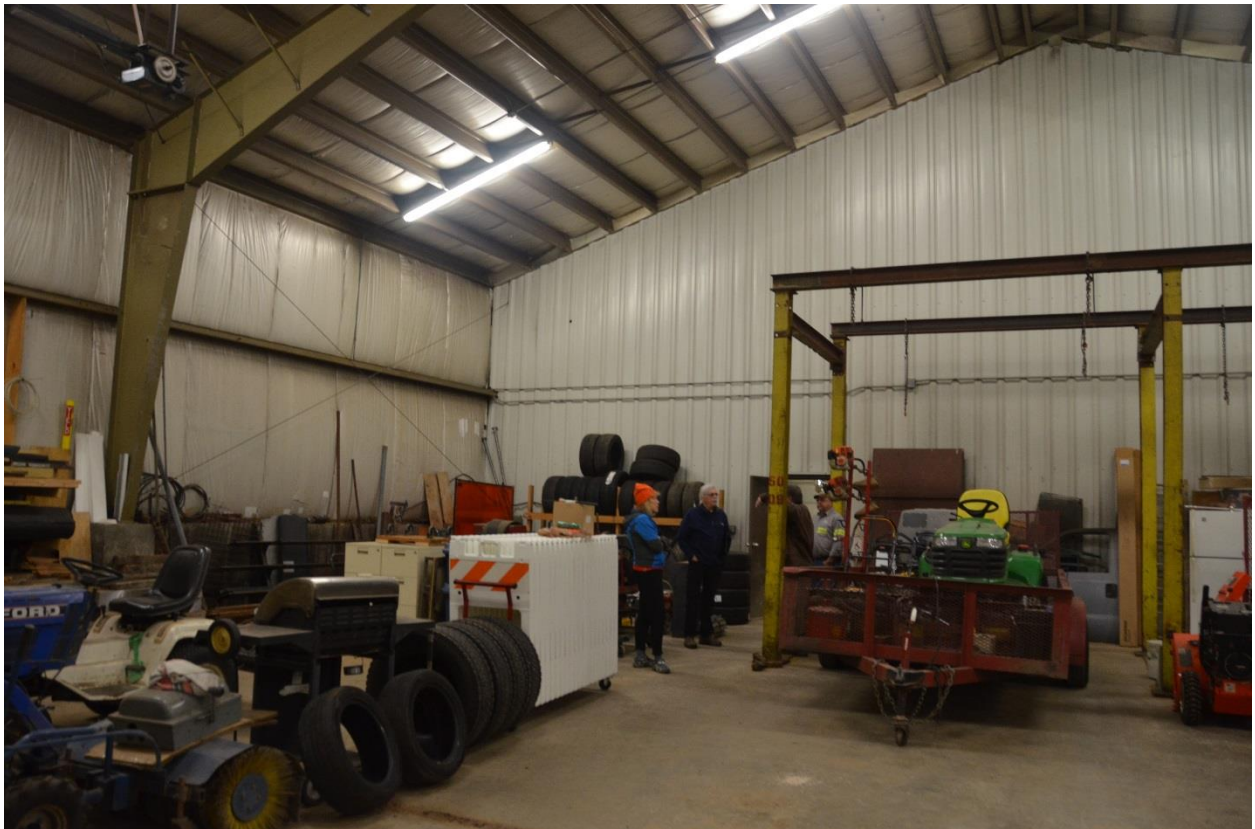
Above: Unheated portion of main building.

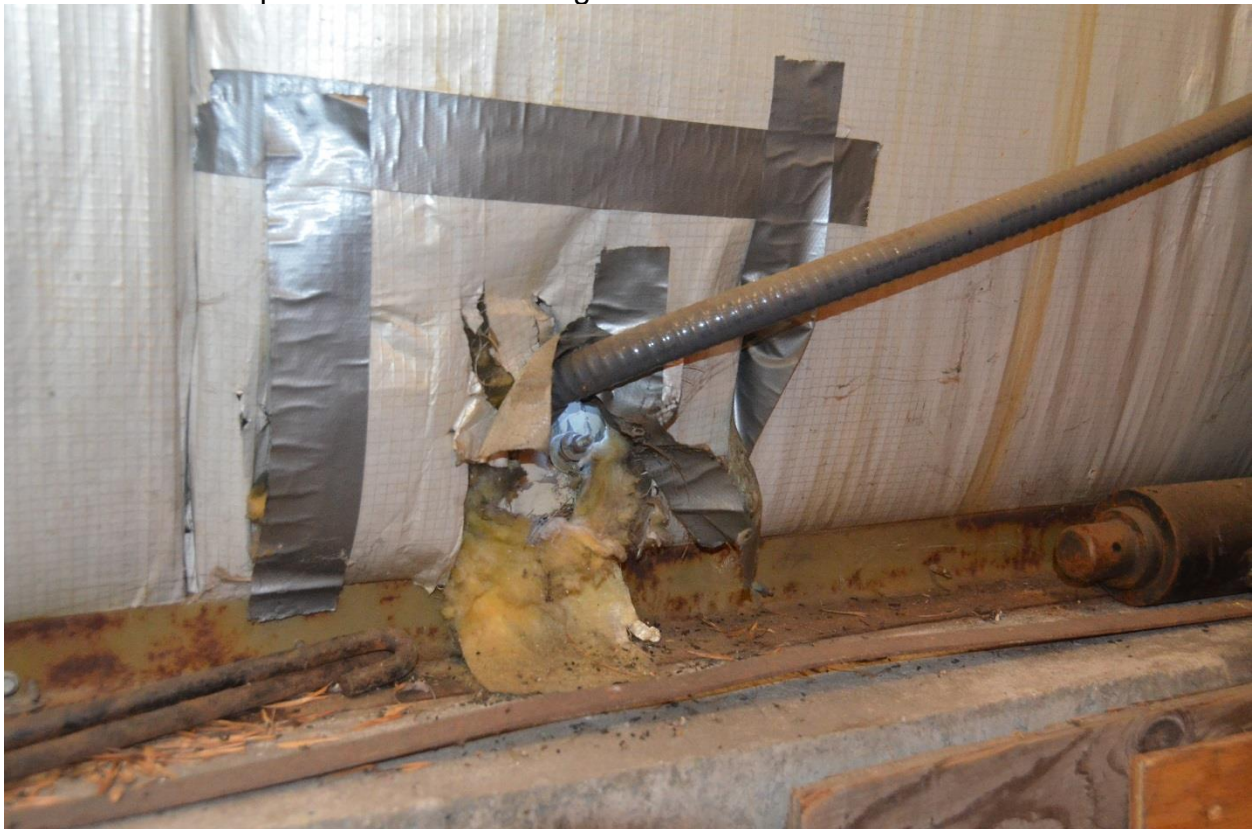
Above: Poor seal (but in unheated portion).

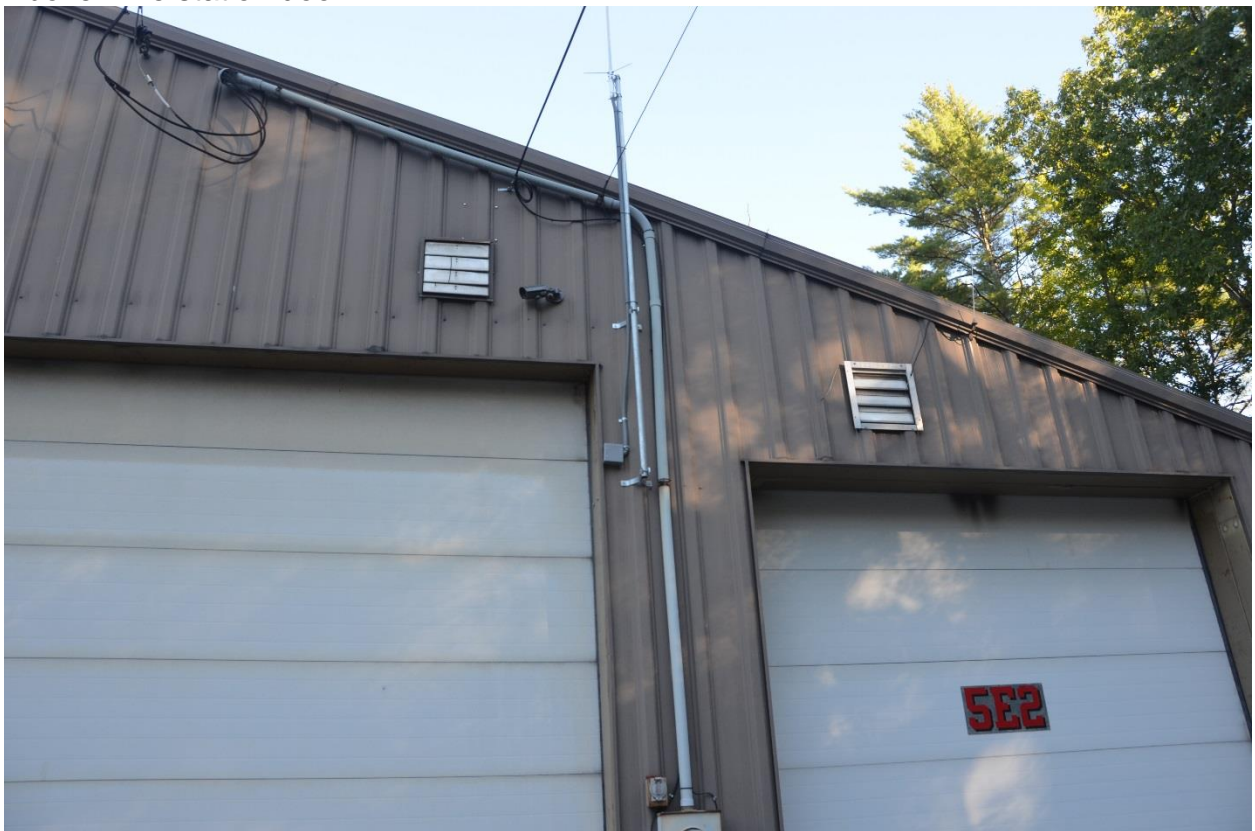
14. The big garage doors are all original. While they appear to be fairly well insulated themselves, we may need to review. The weather stripping is not in good shape however.

Above: Louvered fans may need to be replaced? Weather stripping on doors is not in good shape.
